گزارش حفاظتی یادمان‌های ساسانی طاق‌بستان کرمانشاه در غرب ایران

جانانان کمپ

This article summarises a conservation report written to describe the material condition of a group of Sassanid monuments in Western Iran following a survey executed by the author in August 2007. The article briefly describes the monuments and their surrounding environment before summarising the conservation reports findings on the physical condition and conservation treatments proposed by the author to mitigate the effects of further decay. Reference is made to analysis of samples along with the relevant ethical guidelines under which the conservation treatment proposals have been made. An online glossary of conservation terms is referred to and a brief summary of the results from sample analyses is appended.

Introduction: Taq-e Bostan

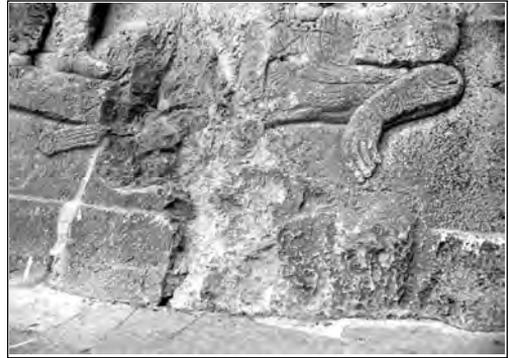
These comparatively recent works may be described as: firstly, a small indent of moulded stone was added to the proper right of the panel as a continuation of its framing; secondly, three large tooled blocks were then added to provide a heavy architrave to nominally aid in shedding water away from the carving on the panel. The line of this feature was roughly projected as far as the furthestmost point of the extant rock, upper proper centre right (Fig. 7).

Unfortunately the author found that any protection that this architrave might have offered is mitigated by the extant rock in the central area with its series of cleavages that allow, in principle, water to run down onto the face of the panel.

Figure 7. detail showing paved area/footing to panel, with hard cement pointing between paving and footing; hard cement pointing to rock fault line; and evidence of the progressive deterioration of fissures through water being prevented from egress by hard cement.

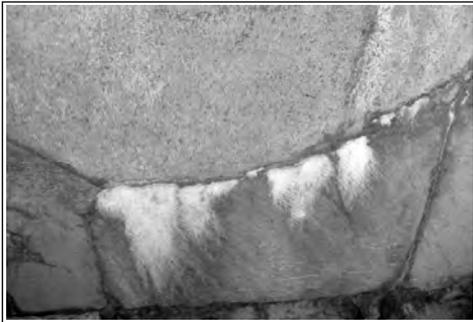
The lower plain panelling to the back of the *iwan*, an area to its lower proper right, and areas to the lower proper left front have all been restored in the 1960 - 70's, with damaged rock cut out and replaced with new stone fixed in cement. Where this restoration work was carried out there is now significant **calcite leaching** with large calcite deposits observable between the new and original stone (Fig. 8).

Figure 8. Calcite leaching between upper original rock and restoration

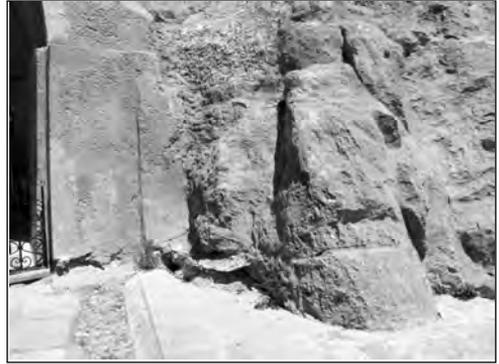
With the paving being brought both a) higher and b) very close to the exterior footings of *iwan* there are signs of **granular disintegration** and **spalling** to the bottom edging of the rock side where water percolation has been prevented, intensifying, for example, the effects of **freeze-thaw cycling** on the stone fabric, and also encouraging **biodeterioration** (Fig. 9).

Figure 9. spalling due to water entrapment and subsequent freeze-thaw cycling

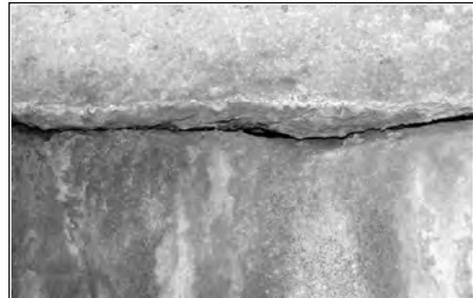
The vestibule of the *ivan* exhibits several of these **fault/vent lines** that have been extensively filled with a hard cementitious material which has largely failed. The consequent diversion and egress of water has caused significant **dissolution** to the the stone as seen, for example, at the uppermost juncture of the *Investiture* carving and the ceiling, and the extensive build up of staining combined with calcitic deposits through water run-off and **calcite leaching** (Fig. 10 & 11).

Figure 10. Dissolution through water run-off

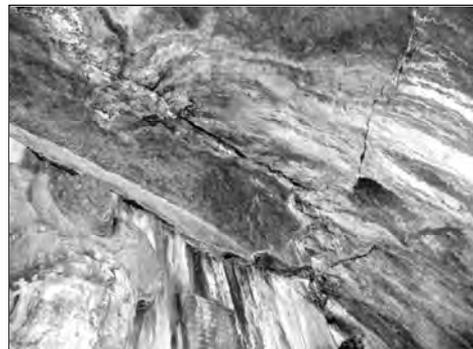
Figure 11. Water run staining with calcite deposits

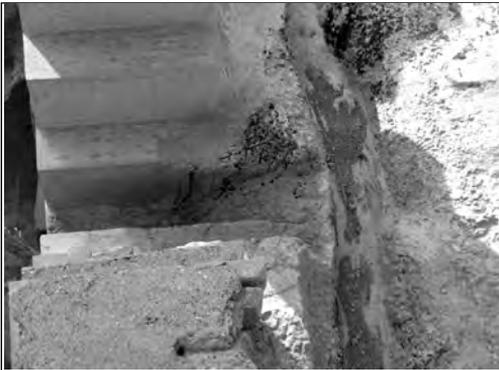
The gully behind the castellations to the facade has been poorly capped in cementitious mortar with an uneven fall created. Furthermore it has not been maintained – cracks and debris are apparent preventing the successful outflow of water away from the *iwan* (Fig. 12).

Figure 12. Debris preventing outflow of rainwater from gully behind renewed castellation.

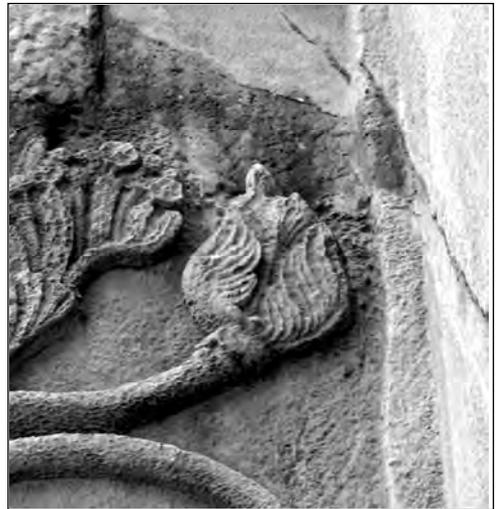
The proper left tree of life panel exhibits extensive surface erosion (approximately 70%), although at the time of inspection it appeared to be stable i.e. no significant **disaggregation** was apparent. There is minor **bioinfestation** present. **Dissolution** and etching occurs in the water washed areas and **sulphation** in the sheltered areas, especially where the new block has been inserted in the upper area (Fig. 13), and the lowermost branches of the tree there are significant areas of **delamination** with associated losses caused by the effects snow build up aggravating **freeze-thaw cycling** (Fig. 14). Cement has been applied to various fracture lines.

Figure 13. Dissolution and sulphation

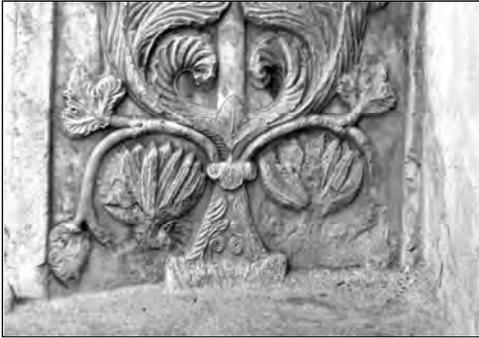
The proper right tree of life panel exhibits approximately 30% surface erosion. As with the proper left panel the lower area exhibits **delamination** with some areas in the process of detachment.

Figure 14. Delamination of lower panel. Sulphation on leaves

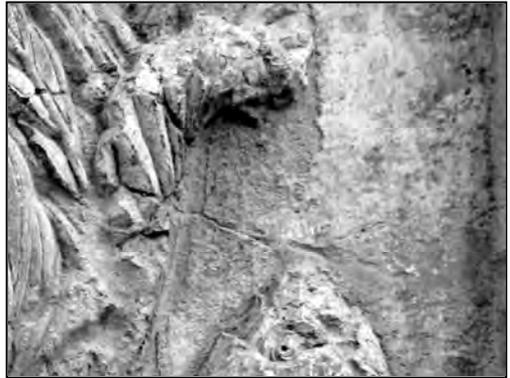
Dissolution and etching occurs in the water washed areas and leaves a pitted topology contrasted with the harder **scialbatura** (Fig. 15). Cement has been applied to various fracture lines inhibiting the egress of water.

smaller *iwān* is probably a Quajar inscription. A **fracture** runs from the upper central moulding through to the proper left capital. In the upper inscriptional pediment there is a large amount of an unknown black pigment used to pick out the carved relief forms of the inscription. On the lower panel and the proper right capital there are very small surface disruptions that appear to be signs of **sulphation**. To the lower proper right through to the centre bottom moulding cement has been applied to a **fracture** line (Fig. 15).

Figure 15. Dissolution contrasted to scialbatura

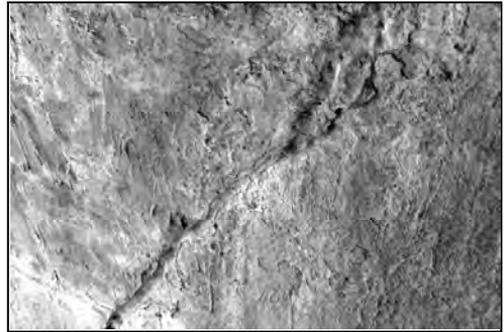
Figure 17. Calcium oxalate and calcite deposits

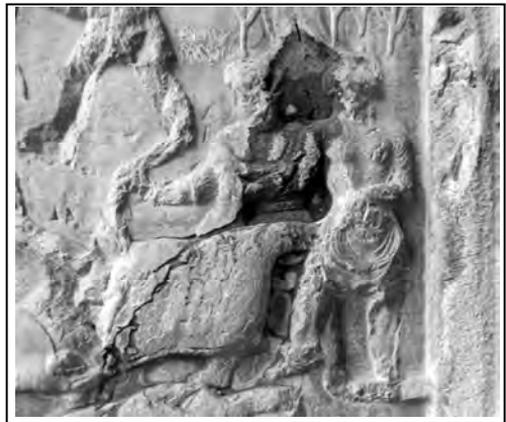
Figure 18. Boar Panel detail

There are various fracture planes where there is seasonal water egress, especially to the upper proper right of the panel; along the large diagonal faultline; and most prominent to the mid-lower proper left (Fig. 18) where significant dissolution and losses have occurred.

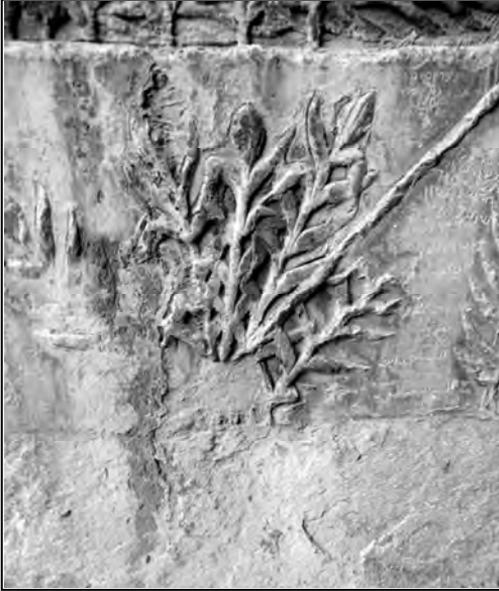
Severe **contour scaling** and **granular disintegration** is taking place at the juncture between the lower area of the panel and the *iwan* floor (Fig. 19). This **contour scaling** is associated with water percolation and entrapment aggravated by both the artificial raising of the water table and, in part, through the diversion of water through the

use of with impermeable cementitious material in previous restoration attempts. Scratched graffiti from various epochs is also present.

Figure 19. Boar Panel: Detail of contour scaling at lower edge

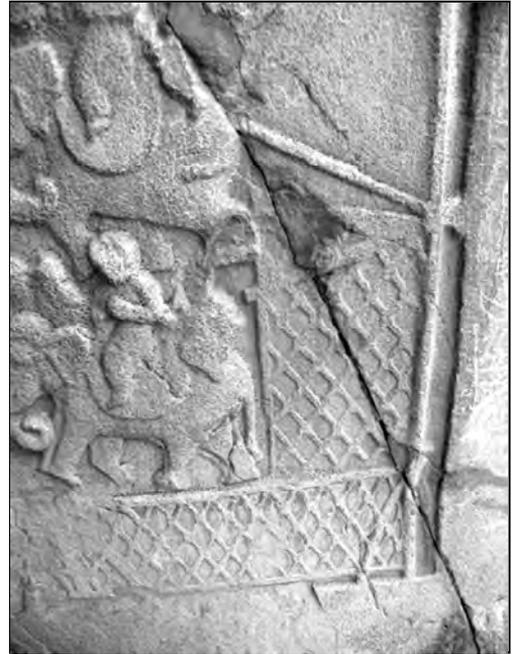
There is one **faultline** running through the panel from the upper proper left central to its lowest point near the front of the *iwān*., another running vertically down in the first third of the panel towards the back of the *iwān*., and a third from near the upper proper right corner running diagonally to the bottom centre proper right area around a new stone insert. They all have been filled with a hard impermeable cementitious material that has generally failed, although less so on the inner fractures. There is noticeable **dissolution** of the stone surface around these fractures (Fig. 20).

Figure 20. Deer Panel: detail of dissolution around impermeable cement

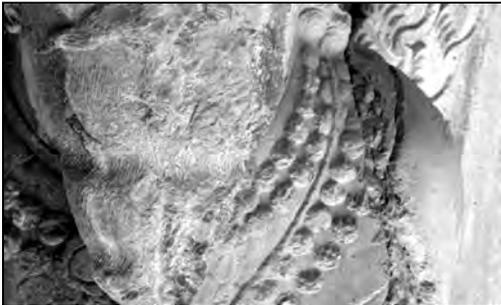
The figures suffer from multiple losses, some through **vandalism**, but also there are fractured areas eg. around the ribbon decoration of the central figure; beneath the proper right arm of the proper right figure; through the proper right shoulder and in the proper right forearm of the central figure; the sword and feet to the central figure; severe fracturing through the proper left side of the proper left figure (Fig. 21). There is also a significant part of the central figure's headdress in danger of becoming completely detached. This headdress also exhibits repairs in hard cement, as does the proper left side of the arch. There is also build ups of sulphation apparent in sheltered areas, for example, behind the various headdresses as well as to the back wall.

Figure 21. Investiture Panel, proper left figure: Detail of fracture and loss to proper left shoulder

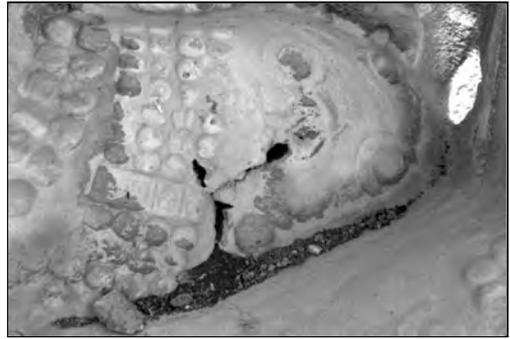
There are significant hollow areas around the proper left shoulder and waistband of the central figure although no **blistering** (Fig. 22). It appeared as though there was **friable** material inside and around the affected areas along with possibly insect activity.

Figure 22. Investiture Panel, central figure: Detail of hollow area and debris

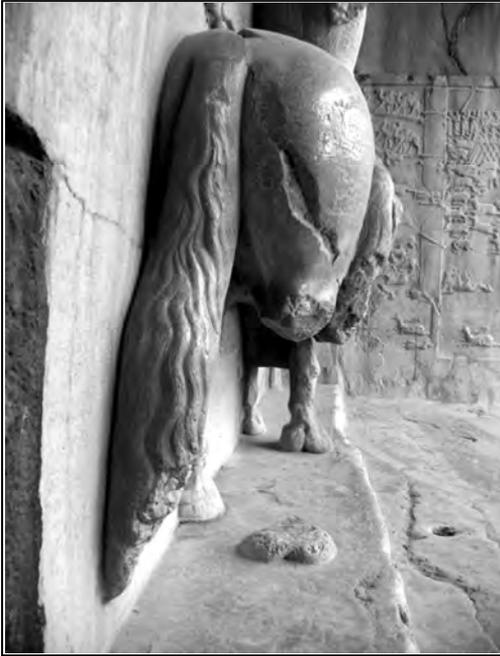
Figure 23. Equestrian Figure: Natural cleavage plane through reverse elevation

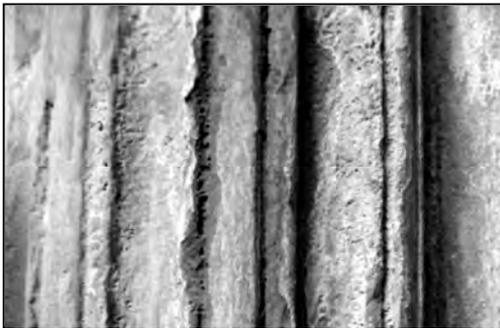
Figure 24. Equestrian Figure, proper left column: Detail of etching to marble and calcium oxalate skin formation
