گزارش حفاظتی یادمان‌های ساسانی طاق‌بستان کرمانشاه در غرب ایران

جانانان کمپ

This article summarises a conservation report written to describe the material condition of a group of Sassanid monuments in Western Iran following a survey executed by the author in August 2007. The article briefly describes the monuments and their surrounding environment before summarising the conservation reports findings on the physical condition and conservation treatments proposed by the author to mitigate the effects of further decay. Reference is made to analysis of samples along with the relevant ethical guidelines under which the conservation treatment proposals have been made. An online glossary of conservation terms is referred to and a brief summary of the results from sample analyses is appended.

Introduction: Taq-e Bostan

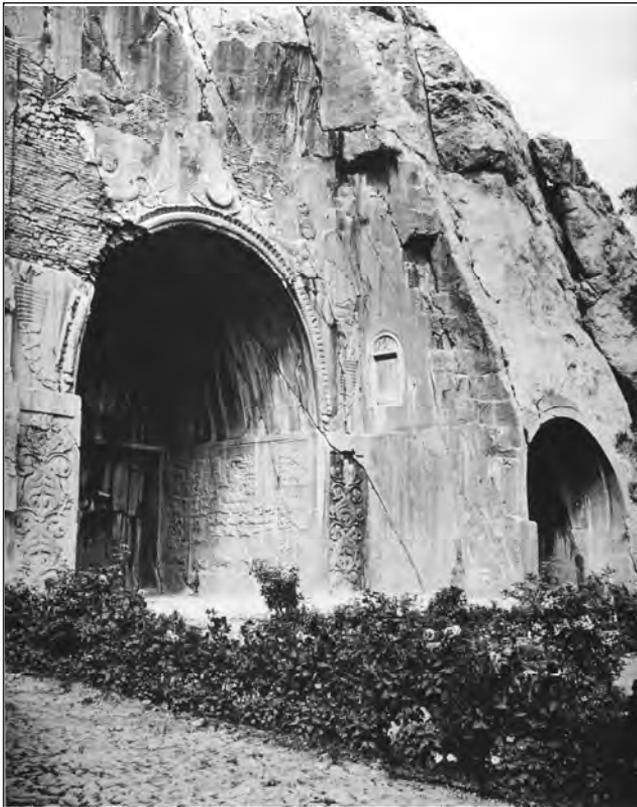
Figure 1. Early 20th Cent. photograph from a 1969 Report by the Institute of Oriental Culture, The University of Tokyo

In the larger *iwan* the junctures between the two hunting panels and the massive equestrian panel indicate a possible chronology of carving because as a matter of practical technique the equestrian panel would have been laid out with its forward most levels being roughed out before the framing of the two side panels, the hunting panels, could be determined (Fig. 1).

Carving directly into the karst formation also meant to carve across or through the naturally occurring fault/vent system typical of karst formations. In the large *iwan* these vents are particularly obvious especially at the apex of the arch – if the carvers had set the arch some 500-1000mm lower it might have mitigated some of the current water ingress problems for the panels below as the water flow would have been projected much further forward away from the face of those panels.

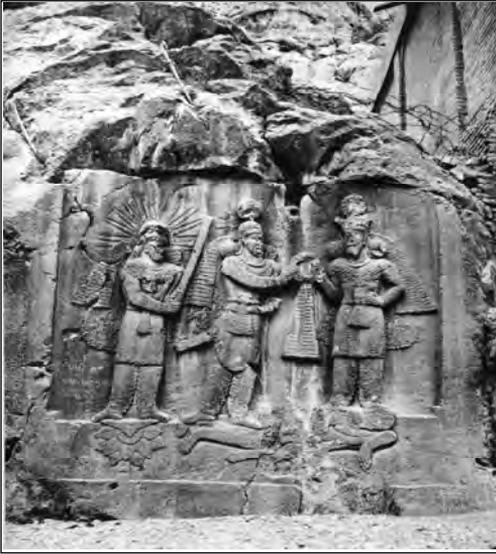
Figure 6. Panel before restoration. Attributed to The Institute of Oriental Culture, The University of Tokyo, ca. 1965

The placement of the stone blocks, to define what might loosely be called the architrave, was photographed during execution in the latter part of the twentieth century. An earlier photograph shows that originally the architrave never projected forward of the relief, which consequently left the panel exposed to inundation from above (Fig. 6).

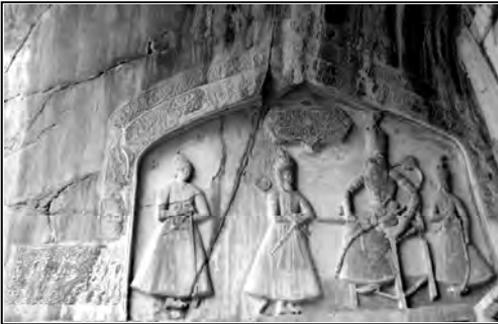
Figure 16. 19th Cent. Qajar Polychromed Panel

The 19th Cent. Qajar Polychromed Panel is a lavishly painted recessed panel of four figures carved in bas-relief (Fig 16) with an inscriptional relief carved framework around in the shape of an ogee arch. A second inscriptional relief is carved above two of the figures, and a further inscriptional relief abuts the frame to the lower proper right.

The most extensive damage is due to gypsum formation as a result of **sulphation** with a significant amount of iron present to give it a characteristic brown discolouration, and further compounded by a calcium oxalate interaction, possibly a product of **bioinfestation** or organic coating. The panel also sits across a significant **faultline** and smaller **vents** where water percolates

through at various points leading to associated **dissolution**, and **scaling**.
